# 2017 Culvert Assessment Report Ashland, New Hampshire

The Lakes Region Planning Commission (LRPC) conducted a GPS inventory of culverts on Class V roads in Ashland, NH. The inventory included not only GPS locations of culverts, but also collection of certain attributes related to the culvert (including overall condition) as identified in the Statewide Asset Data Exchange System (SADES) Data Collection Specification Guide for Culverts, updated and published in 2017 by UNH Technology Transfer Center in partnership with NH DES, NHDOT, and New Hampshire's Regional Planning Commissions (Appendix A). This work was conducted under a contract with the town and with financial support through the NH DOT.

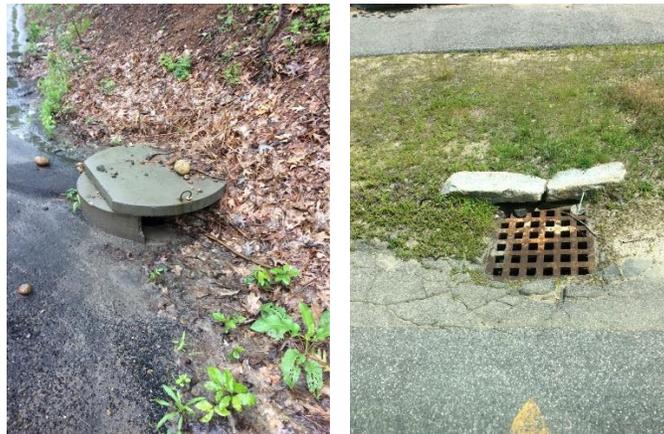
Figure 2: Examples of commonly found ‘Catch Basin Inlets’ in Ashland, NH.  
 (Left: North Ashland Road near Route 3, Right: Highland Street near Cottage Street)

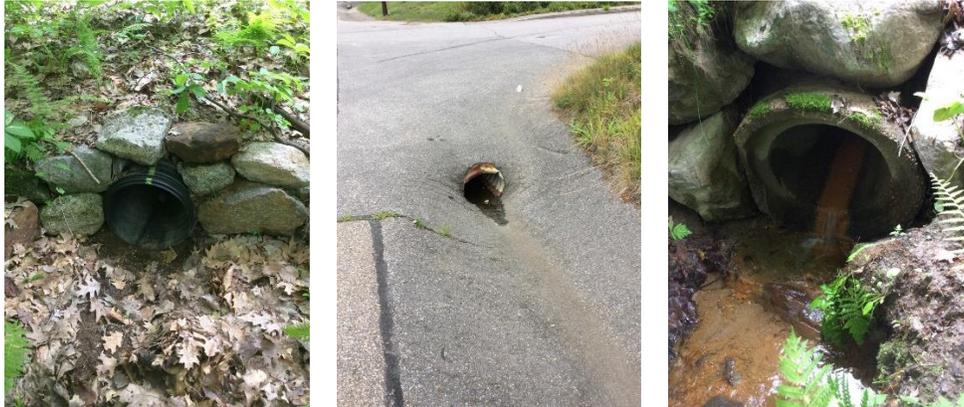
Figure 4: Examples of the most common culvert materials in Ashland, NH.

(Left: Plastic-Smooth\* on Peppercorn Road, Middle: Steel-Corrugated intersection of Hill Ave and Winter Street, Right: Concrete on Owl Brook Road)

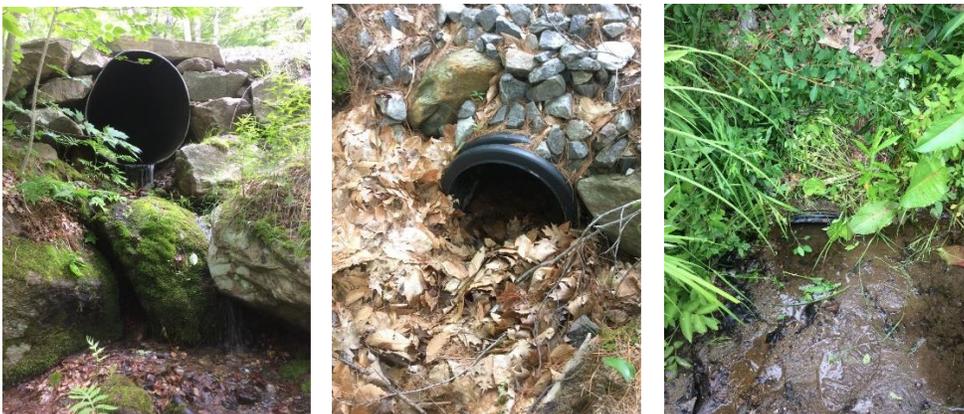
Figure 5: Examples of various amounts of sediment build up in Ashland, NH.

Culverts were assessed for the amount of sediment buildup, they were categorized into five groups (open,  $\frac{1}{4}$  full,  $\frac{1}{2}$  full,  $\frac{3}{4}$  full, and entirely full). The majority of culverts that were assessed for sediment build up are 'open' and free of any obstructions. However, ten of the 80 assessed structures (12.5%) were found to be at least half full. Examples of open,  $\frac{1}{2}$  full, and entirely full culverts are shown in Figure 5. The locations of these are shown in Map 4 "Ashland, NH – Structure Sediment Buildup." Catch basin inlets and some other drainage features were not assessed for this specific attribute, due to inaccessibility.

(Left: Open on Partridge Ln, Middle:  $\frac{1}{2}$  Full on Leavitt Hill Rd near Loon Ln, Right: Entirely Full on Sanborn Rd)

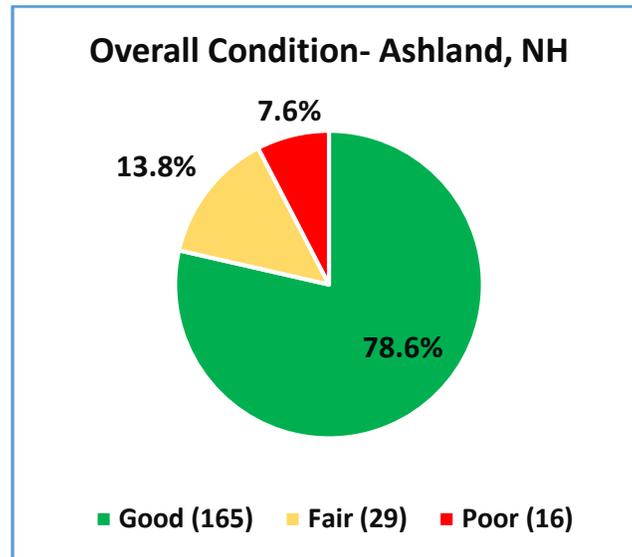
Figure 6: Overall condition of structures in Ashland.

At the end of each culvert and drainage feature assessment the field crew took into consideration the overall structure condition and categorize it as being: good, fair, or poor. Locations of these are illustrated in Map 5 "Ashland, NH – Overall Condition." Most of the structures in Ashland are considered to be in good condition, but nearly 8% were characterized as "poor" overall structure condition (Figure 6).
