Historic Structures Report

Ashland Town Hall

20 Highland Street, Ashland New Hampshire

February 29, 2020

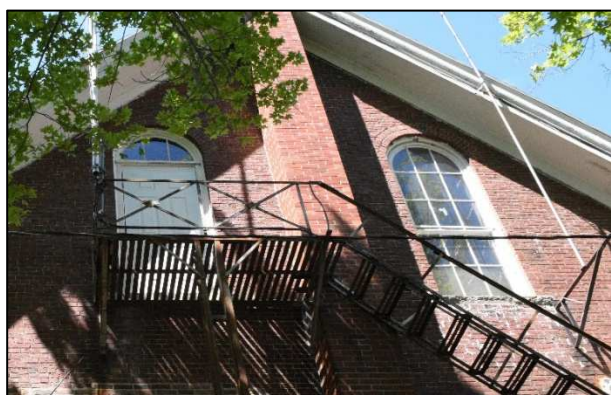
Figure 11: Upper hall level of east elevation (3rd floor)

The window of the south bay of the upper hall (now third floor) has been converted to a doorway (Figure 11). The north window sash appears to be original and historic. The south historic window was replaced by an exterior door beneath a semi-circular curved transom in 1905 when the first exterior fire escape was added. The present exterior door at this level is a modern metal simulated six-panel door. The curved three-light transom above, may be made from part of the historic window that was removed in 1905. The fire escape itself is made from very light steel, with a delicate railing at the third floor level, and along the steps to the second floor level. It is supported by two metal brackets that have been further assisted by the addition of a metal

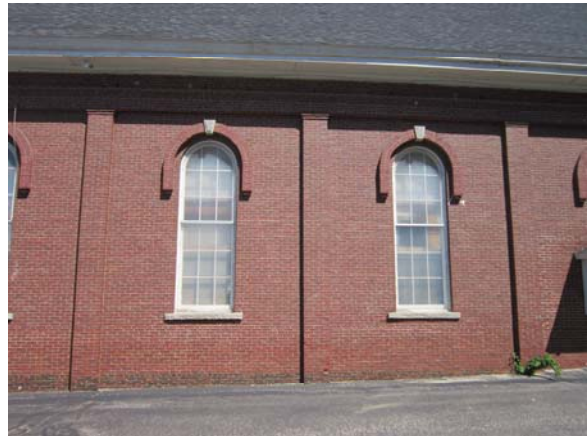
Figure 1 – Exposed foundation of slightly darker brick matches layout of wall brick above. Pavement on raised grade at south elevation conceals most of foundation.

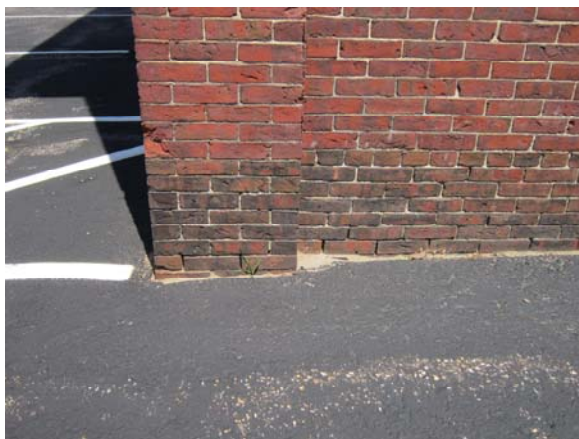
Figure 2 – Brick masonry at bottom of walls, especially those near pavement, exhibit substantial mortar loss due to roof water splashback.

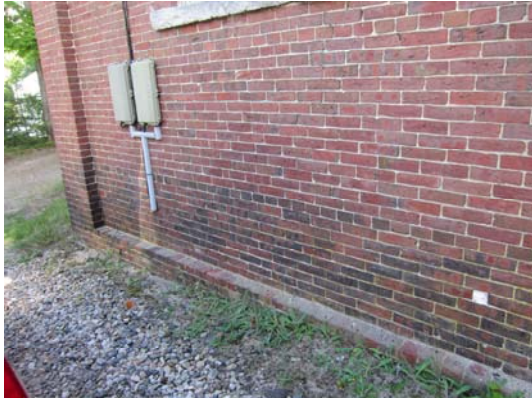
Figure 3 – Ten courses below the header course that marks the top of the foundation, Another header course caps a thickening of the foundation.

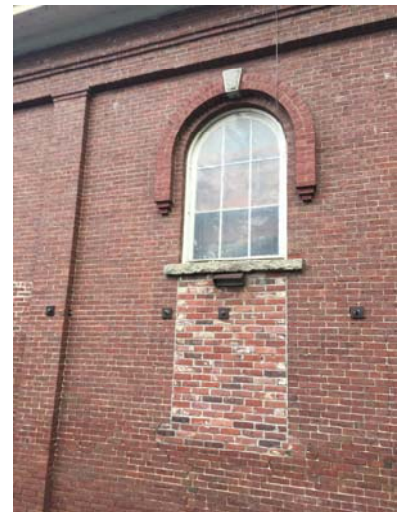
Figure 4 – Previous infill brick poorly matched to original brick – replace poor quality installation

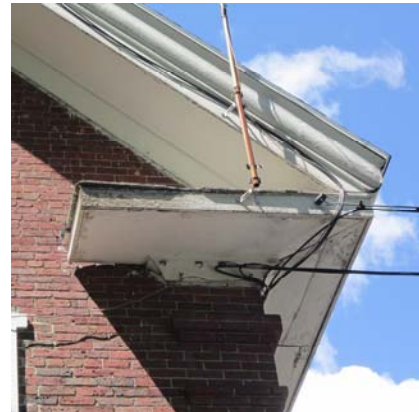
Figure 5 – Water and rodent damaged eave returns should be repaired or rebuilt.

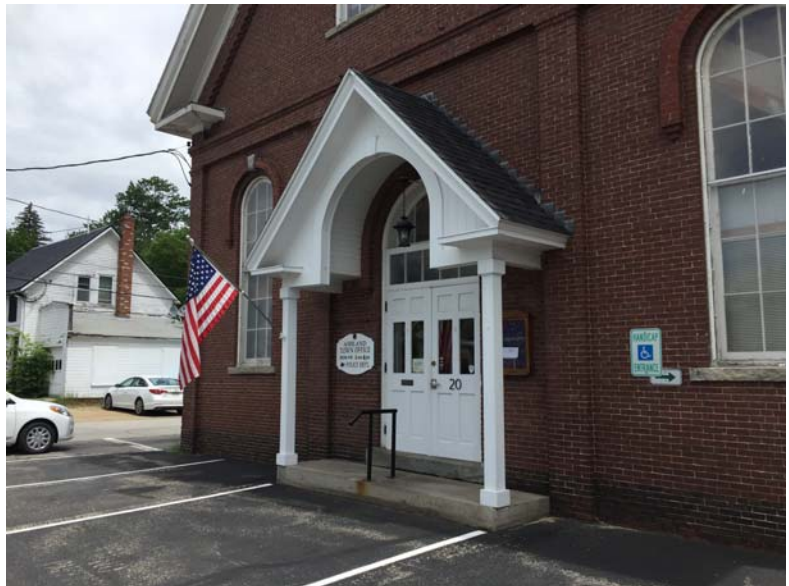
Figure 6 – Entry porch and doors are replacements for the originals. Entry is not handicapped accessible

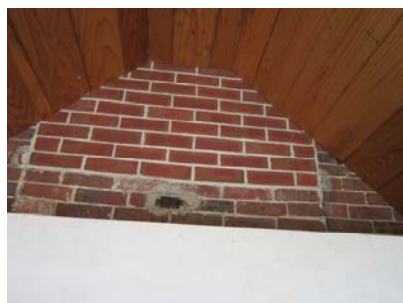
Figure 9 – Poor brick match at the inside of the existing north side portico.

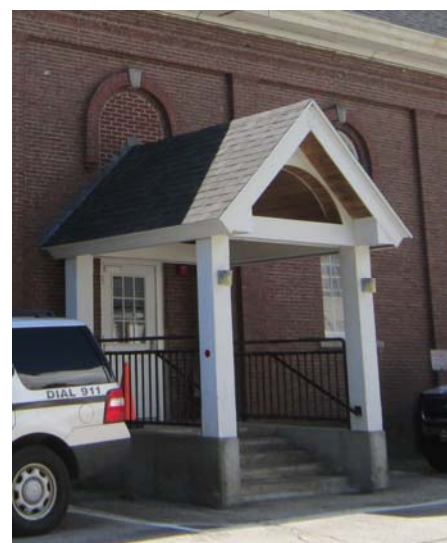
Figure 8 – north side portico is more recent addition to building in good condition

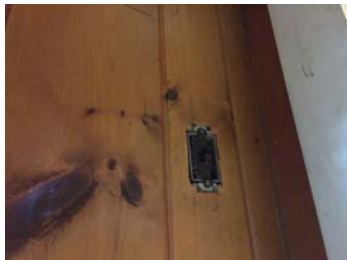
Figure 10 – uncovered light switch in former boys room

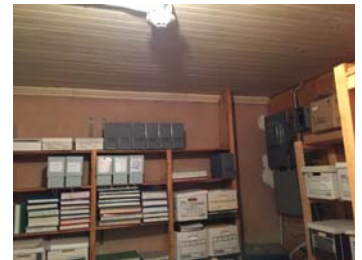
Figure 12 – Uncovered electrical in the 2nd floor file storage area

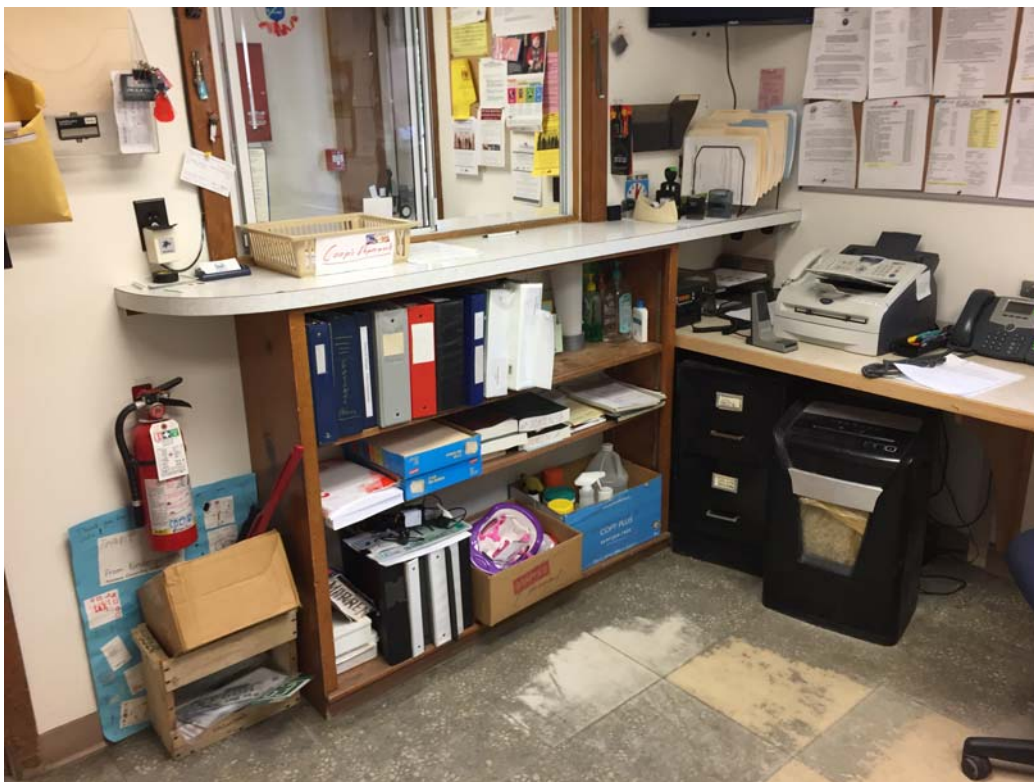
The finishes in the PD area (like those in the dispatch office) are significantly worn.
