# 2017 Culvert Assessment Report Ashland, New Hampshire

The Lakes Region Planning Commission (LRPC) conducted a GPS inventory of culverts on Class V roads in Ashland, NH. The inventory included not only GPS locations of culverts, but also collection of certain attributes related to the culvert (including overall condition) as identified in the Statewide Asset Data Exchange System (SADES) Data Collection Specification Guide for Culverts, updated and published in 2017 by UNH Technology Transfer Center in partnership with NH DES, NHDOT, and New Hampshire's Regional Planning Commissions (Appendix A). This work was conducted under a contract with the town and with financial support through the NH DOT.

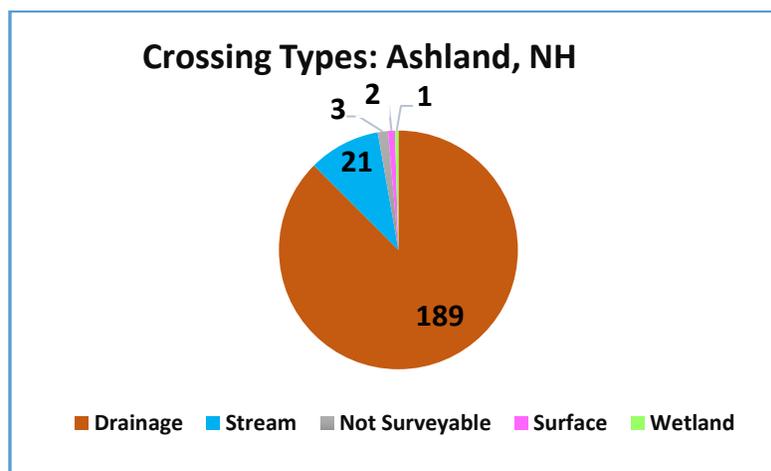
Figure 1: Total number of crossing types in Ashland, NH

After meeting with the Ashland Road Agent and Town Administrator, and reviewing the methodology for culvert assessments, three trained transportation technicians under the supervision of LRPC staff located and assessed 216 culverts and catch basin inlets. Assessments took place between June 29, 2017 and July 14, 2017 with Quality Assurance/Quality Control (QA/QC) extending into August. Figure 1 below shows that of the 216 structures, about 88% were considered to be drainage features (typically water is not present except in the case of a heavy rainfall), about 10% were culverts at the locations of streams (water is present most of the year and has defined banks), and the remaining were either surface water (pond or lake), wetlands (water is present most of the year and have no defined banks), or not surveyable for a variety of reasons (usually due to private property boundary lines). The crossing type and locations are shown in Map 1 "Ashland, NH-Crossing Type 2017." The summer of 2017 was quite rainy; as a result, many drainage culverts had some amount of water in them.

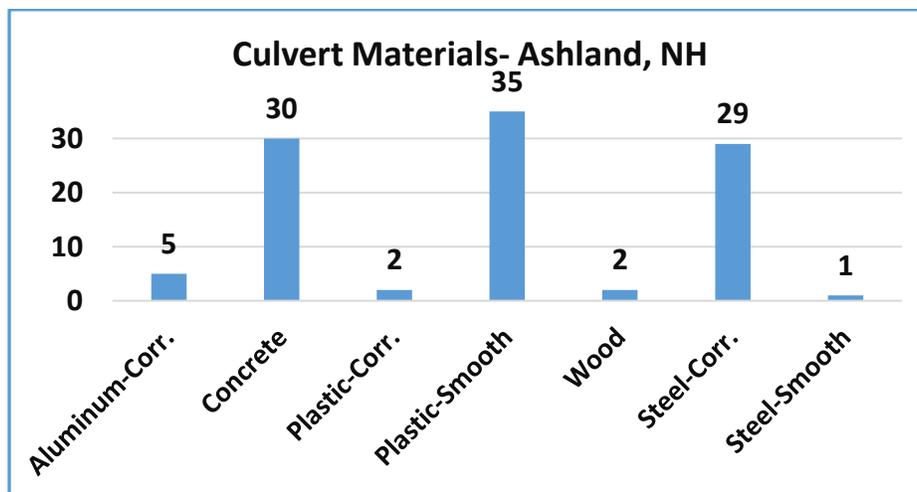
Figure 3: Number of Culverts in Ashland, NH.

The features in Ashland were found to be composed of seven different types of materials. These include: concrete, wood, plastic-corrugated, plastic-smooth, steel-corrugated, steel-smooth, and aluminum corrugated. Figure 3 summarizes the materials identified (not including the 112 storm drain features) and illustrates that the most common material used in Ashland's culverts is plastic-smooth (35 features). We found there were almost as many concrete and steel-corrugated features as plastic-smooth, examples of these materials are shown in Figure 4. There were limited numbers of wood, aluminum-corrugated, plastic-corrugated, and steel-smooth features. The location of these are shown in Map 3 "Ashland, NH- Structure Materials."

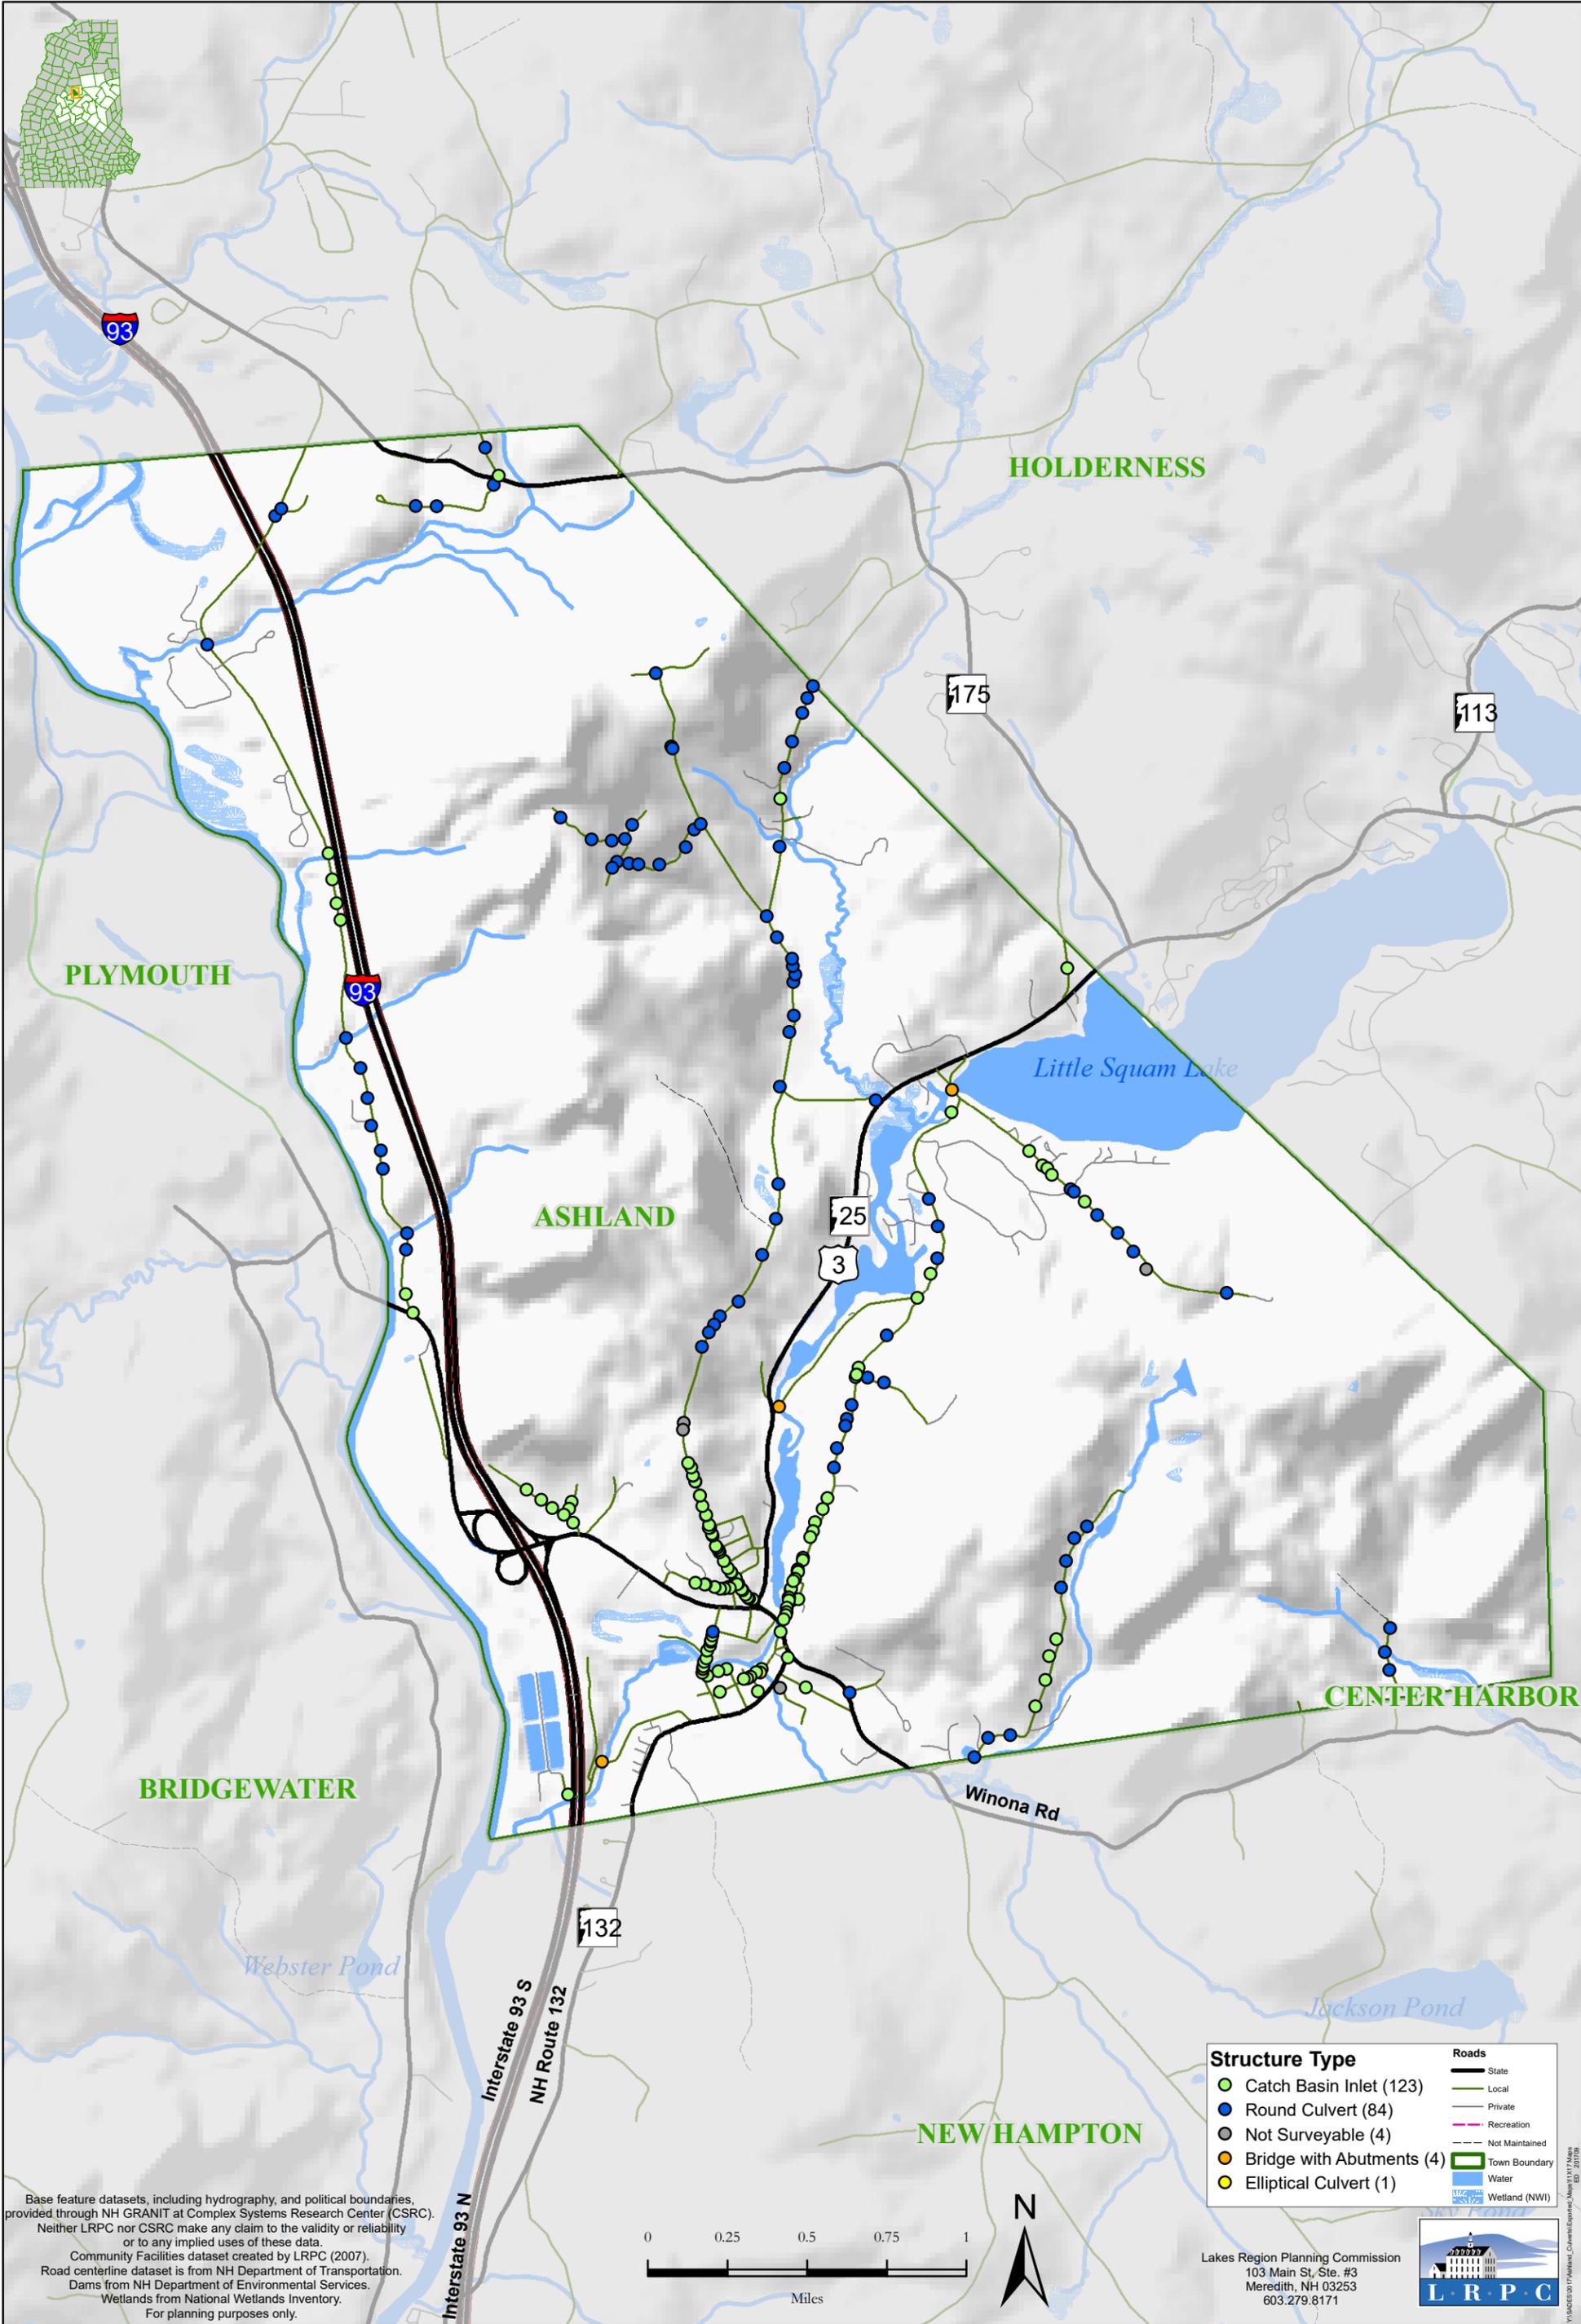
# Structure Type

Culverts and other drainage features such as: catch basin inlets, elliptical culvert, round culvert, and bridges were found along most but not every municipal road. A high number of drainage features such as storm drains and catch basin inlets were found near the center of town on roads such as Highland Street and Thompson Street. Though there is a difference between storm drains and catch basins, this culvert assessment classified both structure types as ‘catch basin inlets,’ with a total of 123 structures. Figure 2 displays examples of the most common catch basin inlets in Ashland. Map 2, “Ashland, NH - Structure Type,” shows locations of the types of culverts and drainage features.

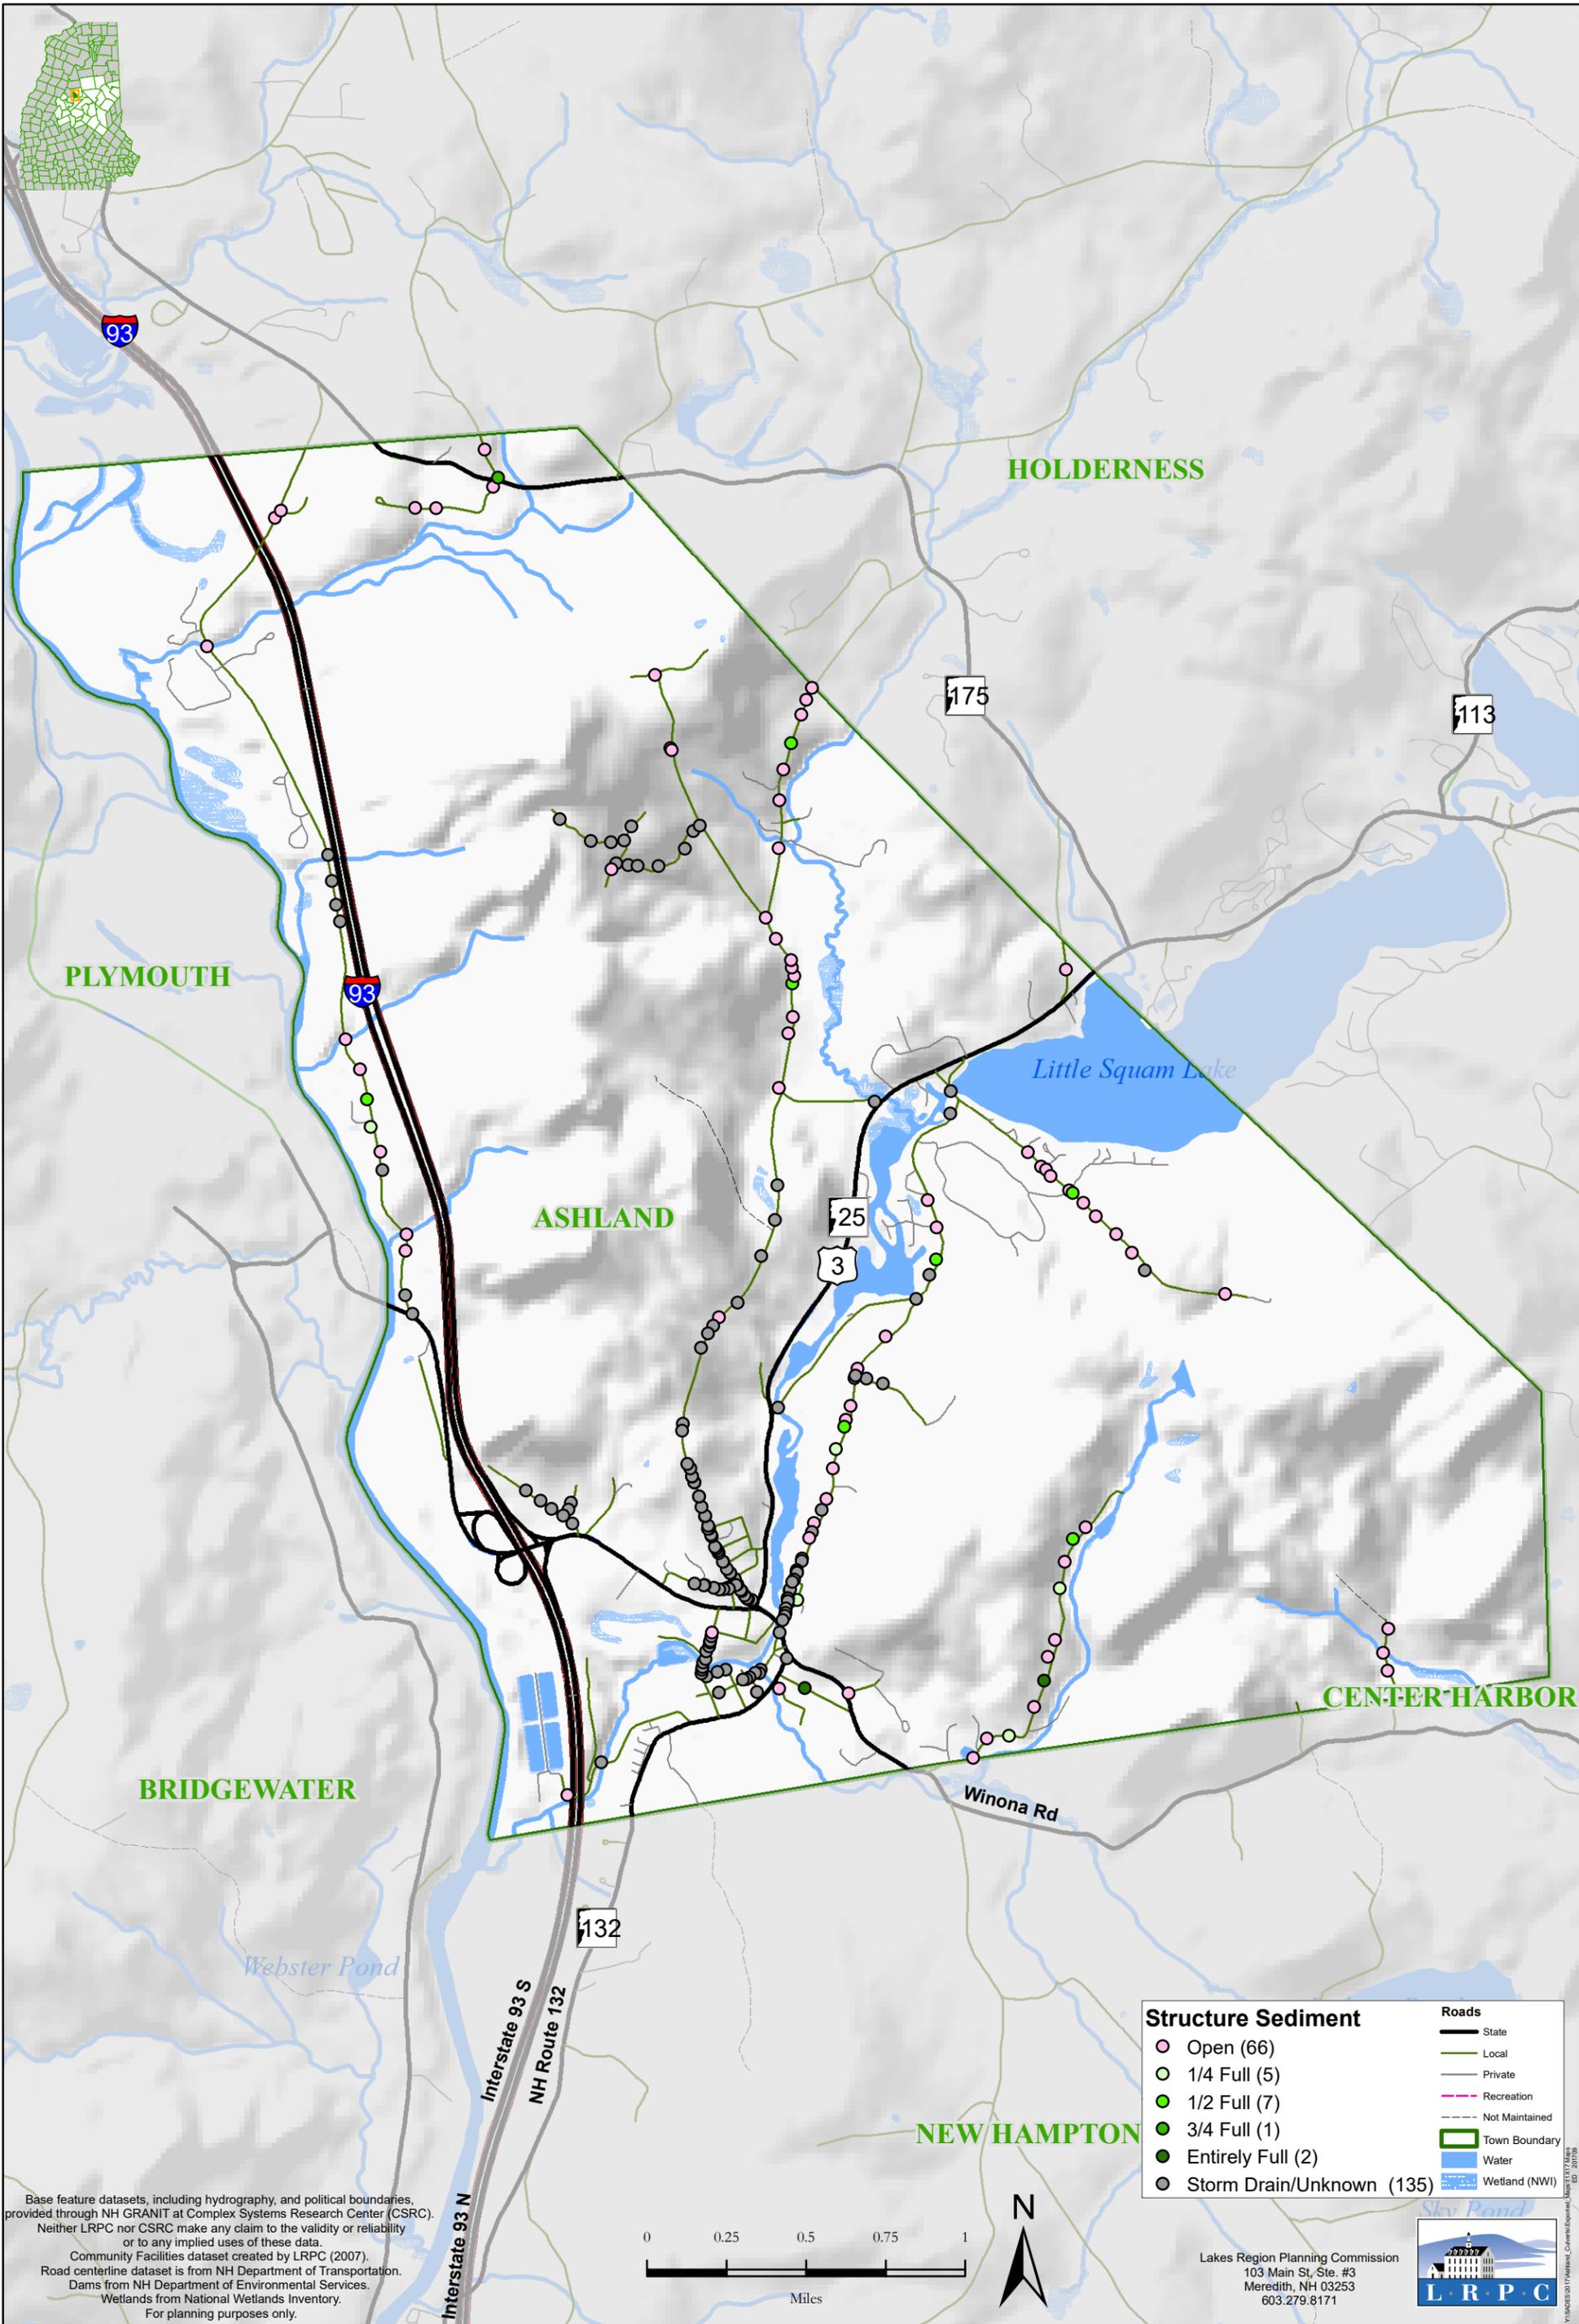
# Structure Sediment

Culverts were assessed for the amount of sediment buildup, they were categorized into five groups (open,  $\frac{1}{4}$  full,  $\frac{1}{2}$  full,  $\frac{3}{4}$  full, and entirely full). The majority of culverts that were assessed for sediment build up are 'open' and free of any obstructions. However, ten of the 80 assessed structures (12.5%) were found to be at least half full. Examples of open,  $\frac{1}{2}$  full, and entirely full culverts are shown in Figure 5. The locations of these are shown in Map 4 "Ashland, NH – Structure Sediment Buildup." Catch basin inlets and some other drainage features were not assessed for this specific attribute, due to inaccessibility.
