Historic Structures Report

Ashland Town Hall

20 Highland Street, Ashland New Hampshire

February 29, 2020

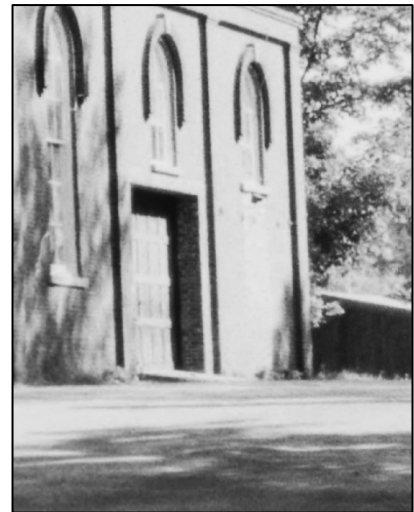
Figure 9: Southeast corner of Town Hall, 1982 showing garage door

in ca. 1952 (Figure 9). The garage door was used by the school shop program and the driver-education car was stored inside. The garage door was removed in 1984, and the modern entrance was created when the area occupied by the garage door was infilled with brick-faced concrete block.

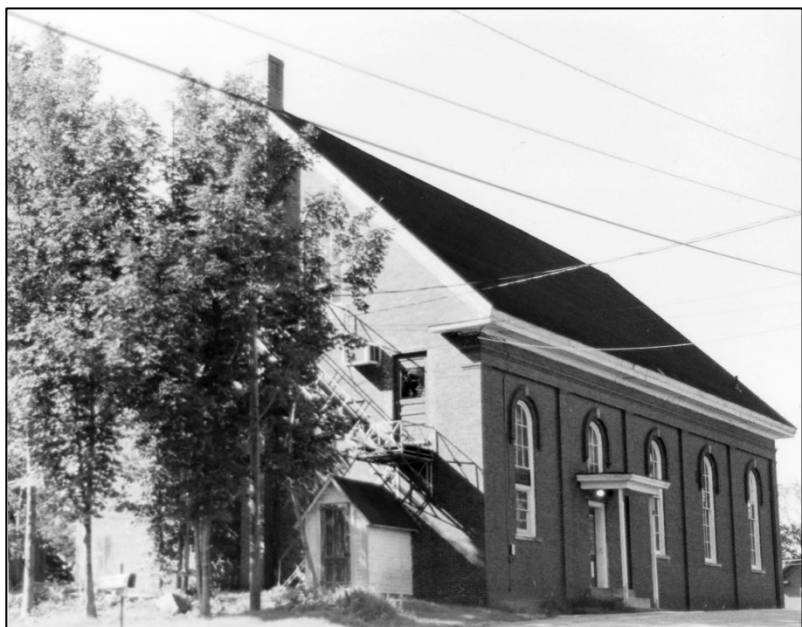
Figure 10: East and north elevations of the Ashland Town Hall in 1982 (Ruell)

lower sash, which has been replaced by a modern 1/1 window and an infill wood panel. The exact date of the alteration of this window is unknown, but it likely occurred in the early 1970s, in conjunction with interior changes to the building.

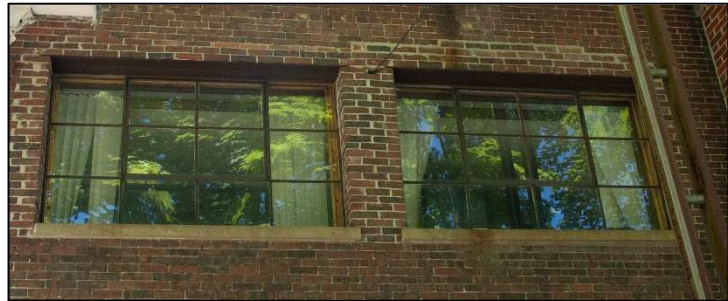
Two large steel windows were also added to the new second-floor level in 1952, to light a second-story classroom (Figure 13). Each of the two windows has a small section within it which opens inward to allow for some air movement. This is the only operable window at the 2nd floor level.

Figure 13: ca. 1952 metal windows (2nd floor)

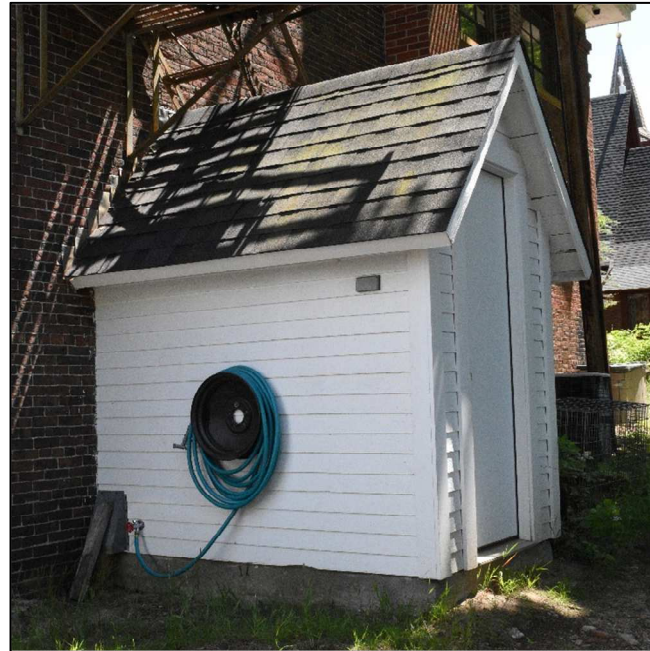
Figure 14: Basement Entry, Ashland Town Hall

There is a small gable-roofed addition at the northeast corner of the building (Figure 14). This shelters and protects the exterior stairs that lead into the small basement of the Town Hall. The exact date of this addition is unknown. It was likely added in the 1970s, as it is constructed of modern dimensional lumber and was present by the 1982 National Register nomination photographs. The addition has a poured concrete foundation, wood clapboard sheathing with narrow flat cornerboards, and a gable roof that has been sheathed in asphalt shingles. The entry is through a modern flat metal door at the gable end.

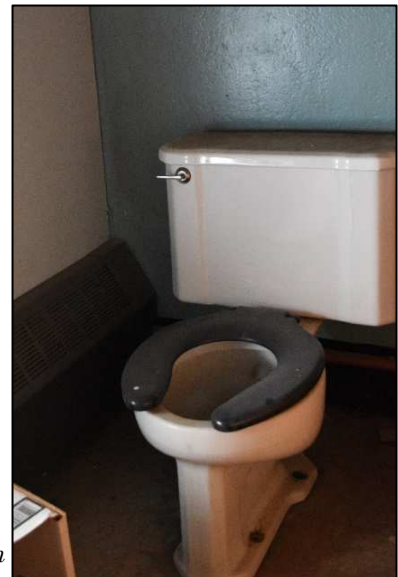
To the north of the Town files is an L-shaped men's room. This bathroom is currently used as overflow storage and has been out of service for many years. The bathroom retains a 1950s toilet and urinal (Figure 19). Interior walls of the room are a mixture of plaster and knotty pine, and the floor is vinyl tile.

Figure 19: 1950s toilet in men's room

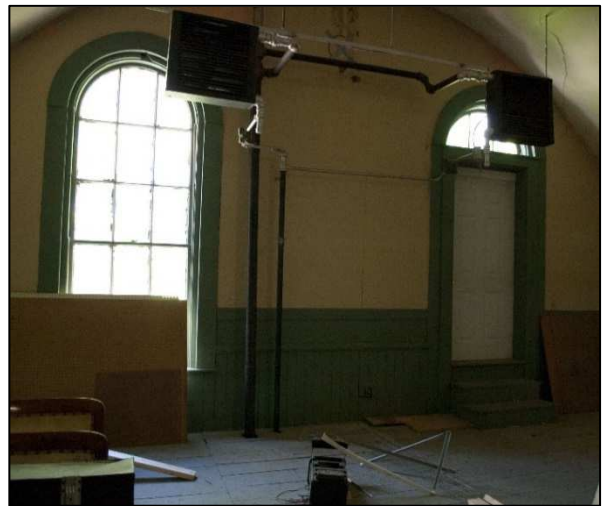
There is a low dais at the east end of the room, below two window openings. The southeast window sash was removed in 1905, when the fire escape was added (Figure 29). The modern metal exterior door is within the former window opening, at the top of a set of wooden steps. The northeast window remains operational and retains the original 1870s sash. There is an historic stove-pipe thimble near the ceiling to the exterior chimney at the center of the east wall. There are two mid-20th century metal heaters hanging from the ceiling at the east end of the room.

Figure 29: East wall of Upper Hall

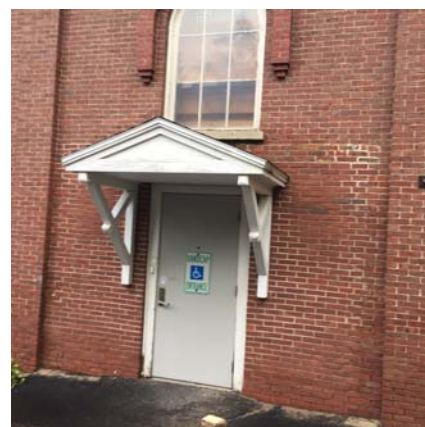
The smaller entry canopy over the side entry at the south façade is supported by applied brackets in good condition. The paint on the face of the gable end shows wood grain, indicating improper priming, though the paint remaining is bonded well with the wood substrate. The entry door the canopy protects is a three foot wide flush metal door. A doorbell on the doorframe allows for handicapped access through the locked door. An area of sloped asphaltic pavement creates a make-shift ramp for such access, though this measure is non-compliant with the standards of the Americans with Disabilities Act. See the section later in this report for details on the building's accessibility. The flat inset casings with brickmold trim are deteriorated at their bases, markedly so on the western side of the door.

Figure 7 – South Side Entrance

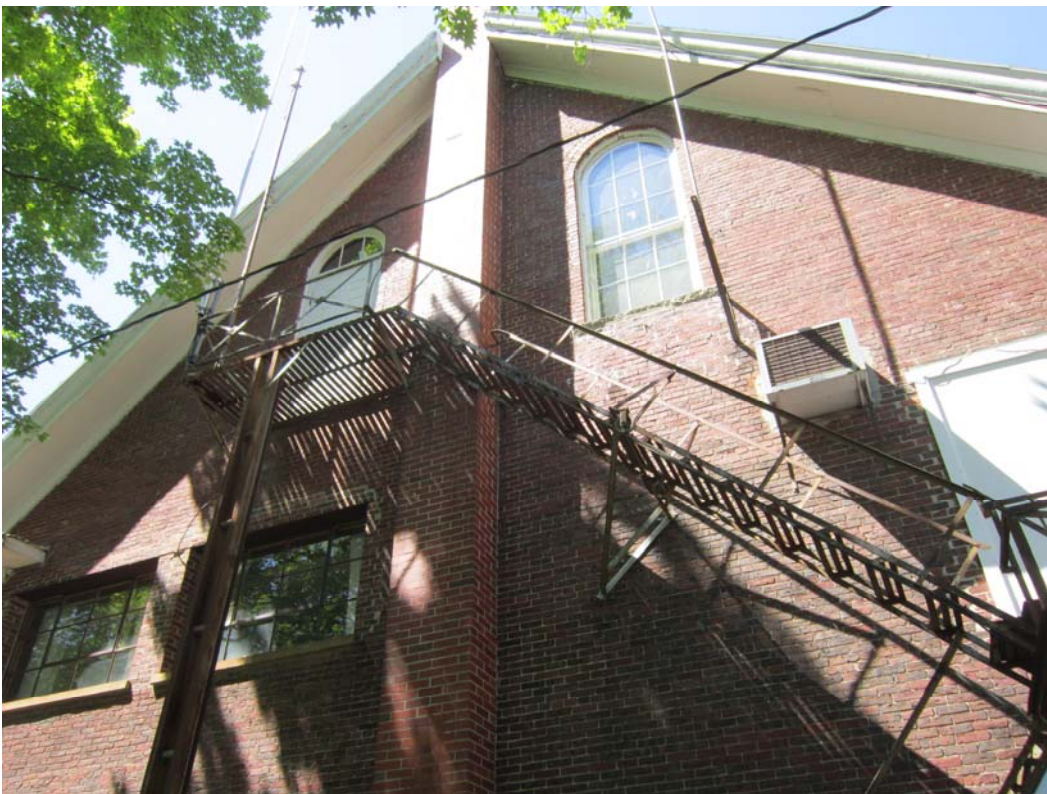
Previous renovations to the north façade include a fire escape with exit doors at the second and third floors, and steel windows punched through what was originally a blank wall.

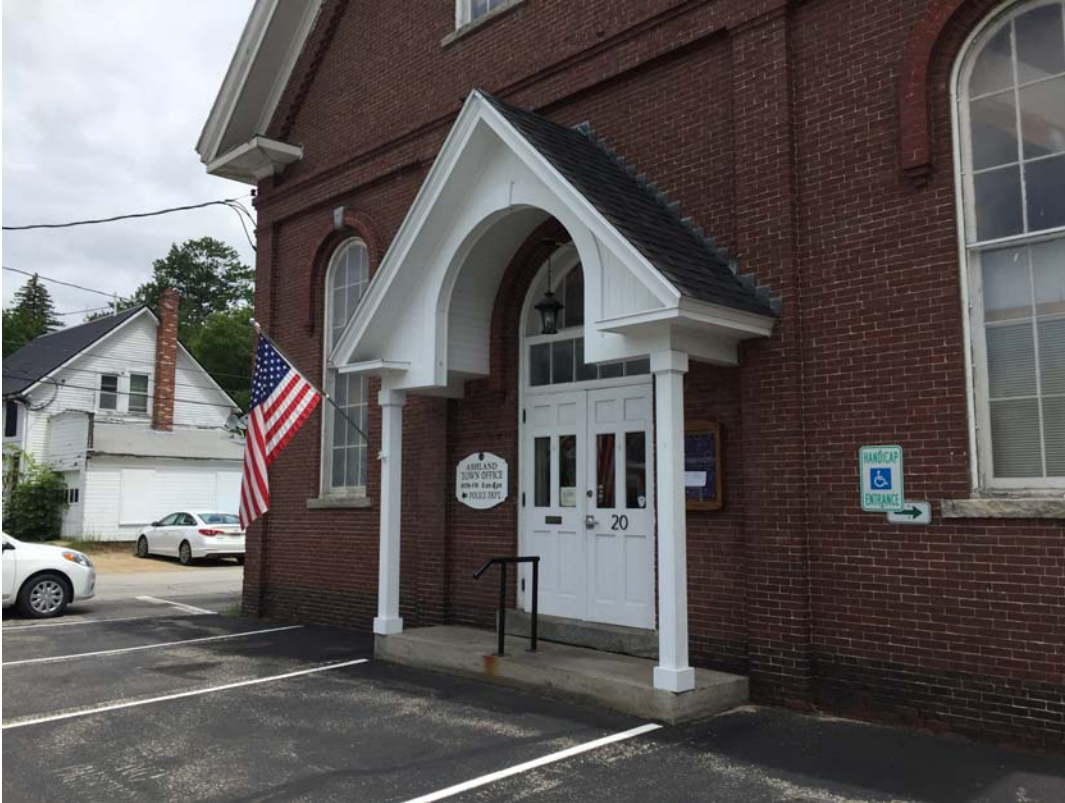
The re-worked main entry of the Ashland Town Hall is not handicapped accessible.

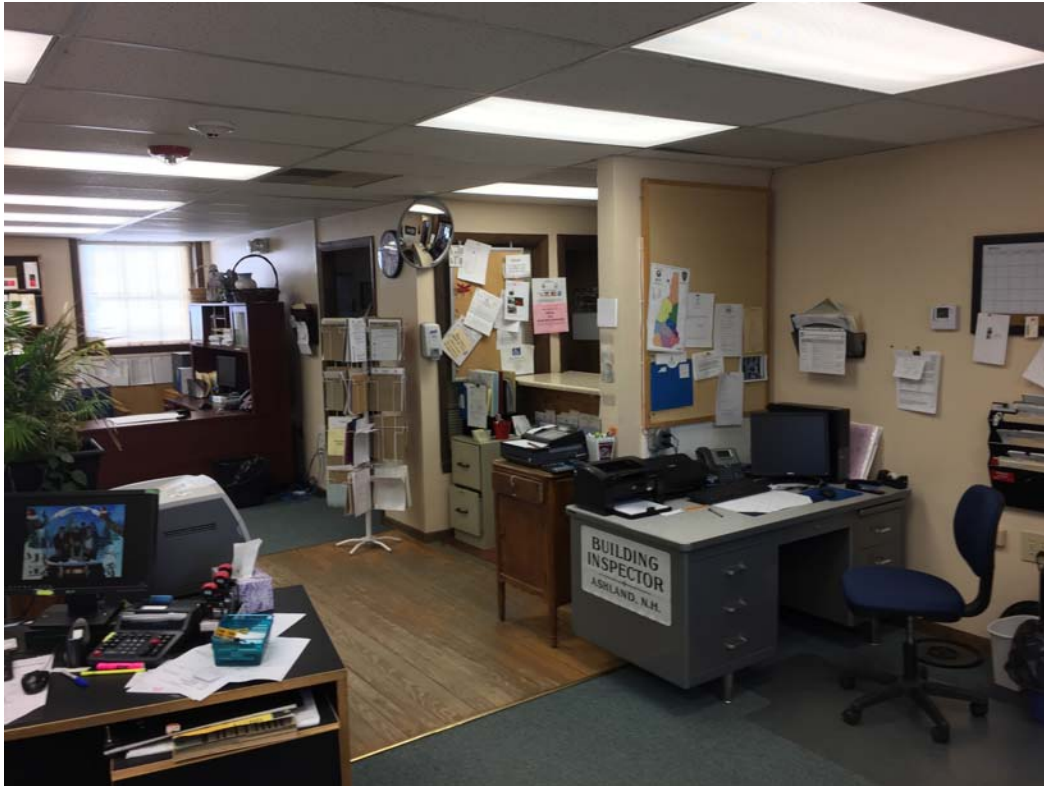
Town offices looking toward service counter. Note the window in the background is the bottom of a large arched-top window in the south façade. Little remains of the original interior on this level.

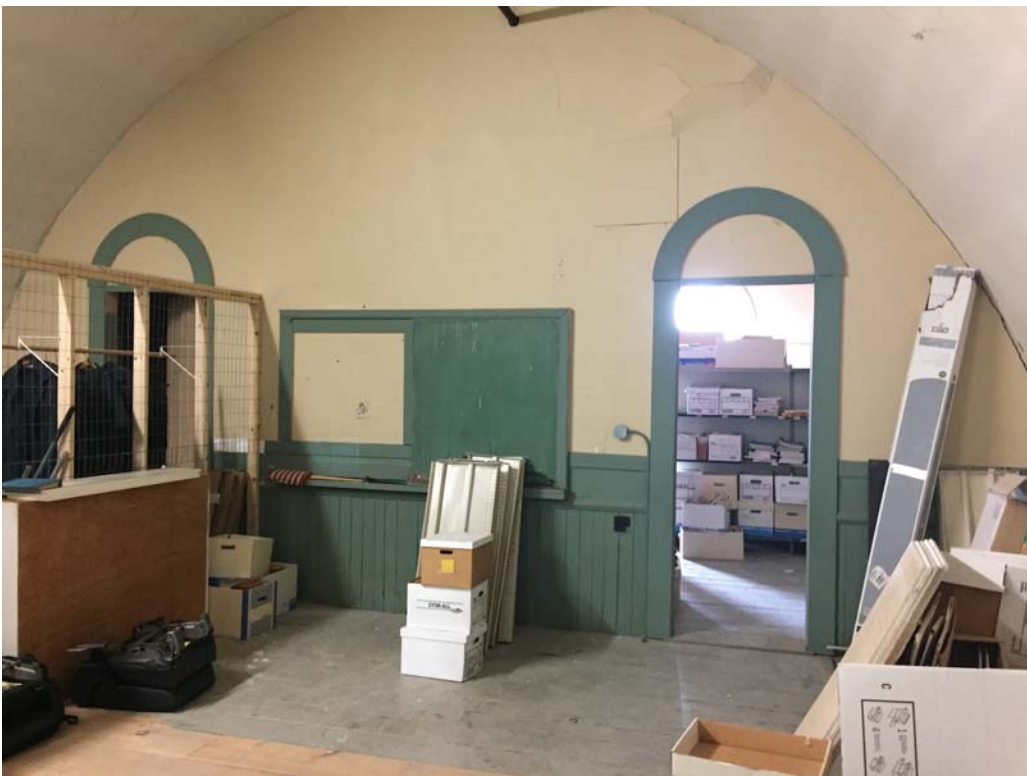
The entrance doors to the barrel-vaulted original second floor Hall (now the third floor and used for storage). The floor on this level will require reinforcement to support more than light storage.

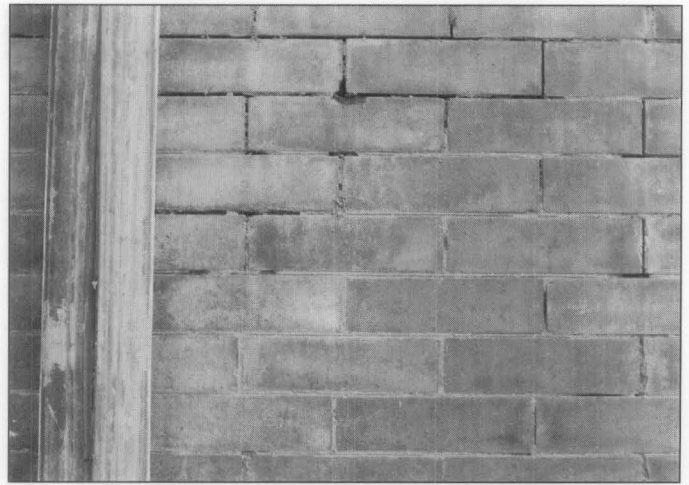
Figure 2. Much of the mortar on this building has been leached away by water from a leaking downspout. The downspout must be replaced and any other drainage problems repaired before repointing. Photo: Robert C. Mack, FAIA.

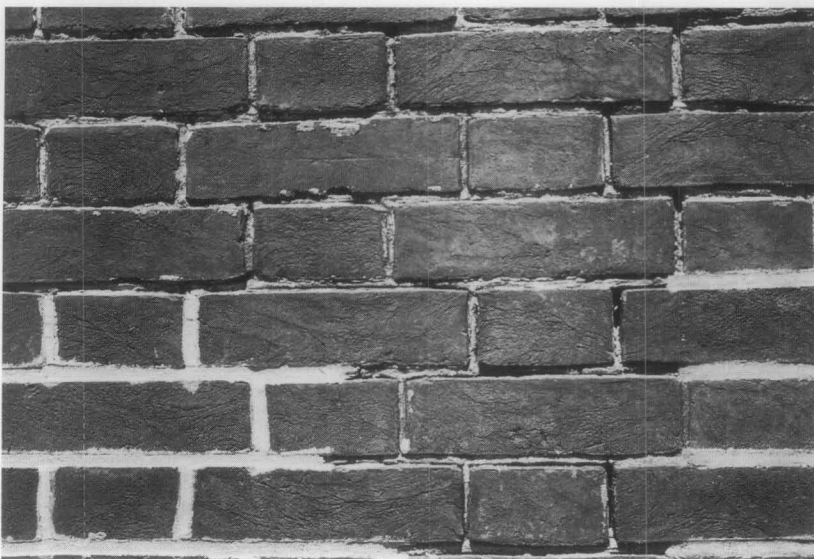
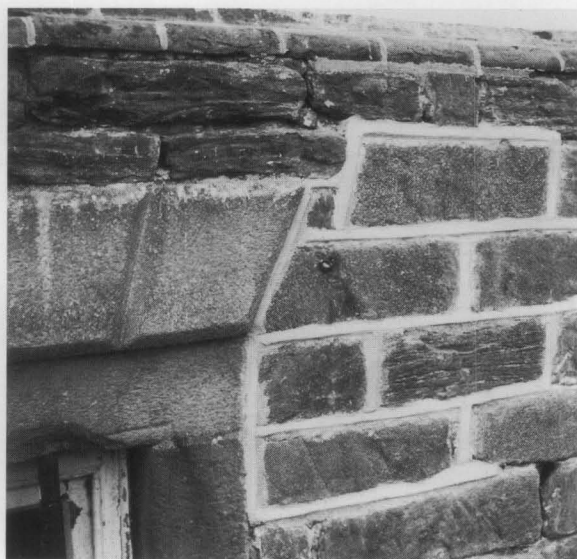
Figure 4. (left) The poor quality of this repointing—it appears to have been “tooled” with the mason’s finger—does not match the delicacy of the original beaded joint on this 19th-century brick wall. (right) It is obvious that the repointing on this “test patch” is not an appropriate replacement mortar joint for this early-19th century stone foundation. Photos: Lee H. Nelson, FAIA.

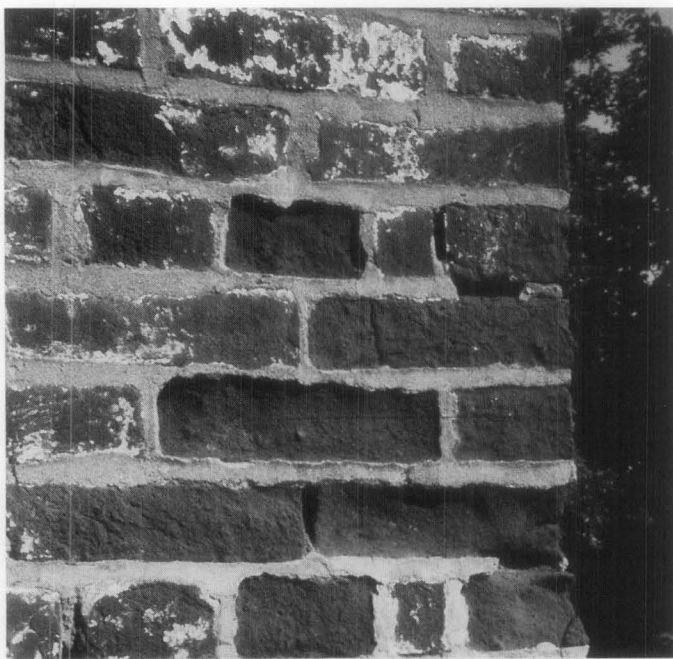
Figure 5. The use of hard, portland-cement mortar that is less permeable than the soft bricks has resulted in severe damage to this brick wall. Moisture trapped in the wall was unable to evaporate through the mortar which is intended to be sacrificial, and thus protect the bricks. As a result the moisture remained in the walls until water pressure eventually popped the surface off the bricks. Photo: National Park Service Files.

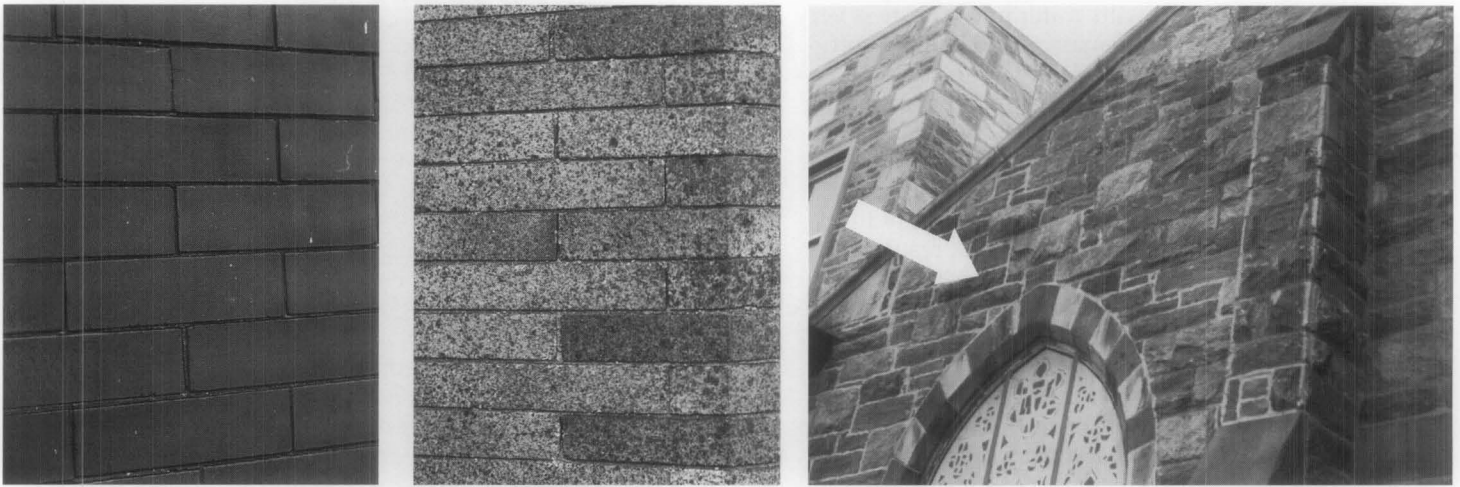
Figure 6. Tinted mortar. (left) Black mortar with a beaded joint was used here on this late-19th century hard pressed red brick and, (center) a dark brown tinted mortar with an almost flush joint was used on this early-20th century Roman brick. (right) When constructed at the turn-of-the-century, this building was pointed with a dark gray mortar to blend with the color of the stone, but the light-colored mortar used in spot repointing has destroyed this harmony and adversely impacts the building's historic character. Photos: Anne Grimmer.

Pigments. Some historic mortars, particularly in the late 19th century, were tinted to match or contrast with the brick or stone (Fig. 6). Red pigments, sometimes in the form of brick dust, as well as brown, and black pigments were commonly used. Modern pigments are available which can be added to the mortar at the job site, but they should not exceed 10 per cent by weight of the portland cement in the mix, and carbon black should be limited to 2 per cent. Only synthetic mineral oxides, which are alkali-proof and sun-fast, should be used to prevent bleaching and fading.

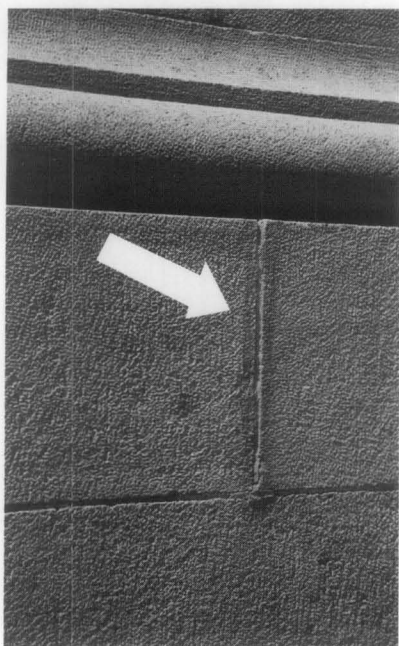
Figure 7. The dark stain on either side of the vertical joint on this sandstone watertable probably resulted from the use of a bonding agent that was not properly cleaned off the masonry after repointing. Photo: Anne Grimmer.

Generally, modern chemical additives are unnecessary and may, in fact, have detrimental effects in historic masonry projects. The use of antifreeze compounds is not recommended. They are not very effective with high lime mortars and may introduce salts, which may cause efflorescence later. A better practice is to warm the sand and water, and to protect the completed work from freezing. No definitive study has determined whether air-entraining additives should be used to resist frost action and enhance plasticity, but in areas of extreme exposure requiring high-strength mortars with lower permeability, air-entrainment of 10-16 percent may be desirable (see formula for "severe weather exposure" in **Mortar Type and Mix**). Bonding agents are not a substitute for proper joint preparation, and they should generally be avoided. If the joint is properly prepared, there will be a good bond between the new mortar and the adjacent surfaces. In addition, a bonding agent is difficult to remove if smeared on a masonry surface (Fig. 7).

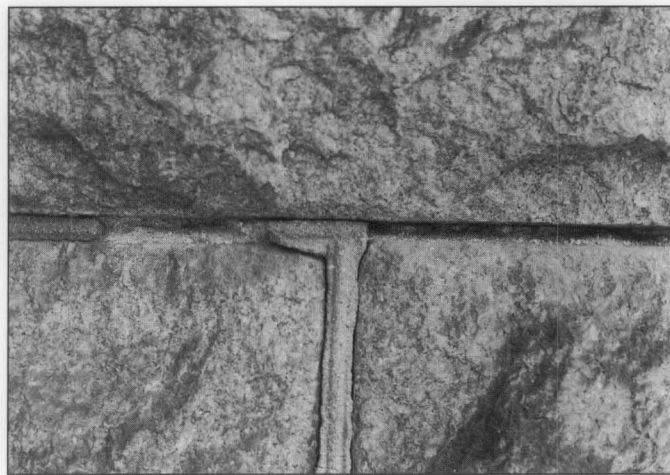
Figure 8. Due to inadequate joint preparation, the repointing mortar has not adhered properly and is falling out of the joint. Photo: Robert C. Mack, FAIA.

Joint Preparation. Old mortar should be removed to a minimum depth of 2 to 2-1/2 times the width of the joint to ensure an adequate bond and to prevent mortar "popouts" (Fig. 8). For most brick joints, this will require removal of the mortar to a depth of approximately 1-1/2 to 1 inch; for stone masonry with wide joints, mortar may need to be removed to a depth of several inches. Any loose or disintegrated mortar beyond this minimum depth also should be removed (Fig. 9).

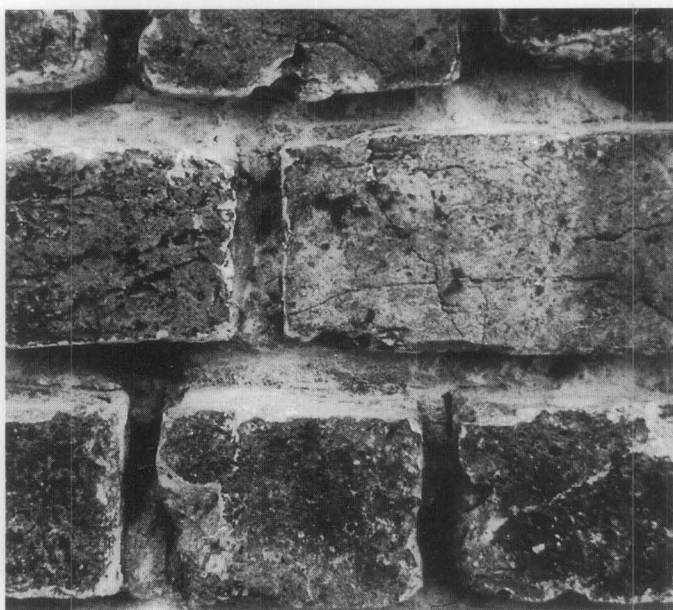
Figure 11. The damage to the edges and corners of these historic bricks was caused by using a mechanical grinder to rake out the joints. Note the overcutting of the head joint and the damage to the arises (corners) of the bricks. Photo: Lee H. Nelson, FAIA.

The most common method of removing mortar, however, is through the use of power saws or grinders. The use of power tools by unskilled masons can be disastrous for historic masonry, particularly soft brick. Using power saws on walls with thin joints, such as most brick walls, almost always will result in damage to the masonry units by breaking the edges and by overcutting on the head, or vertical joints (Fig. 11).

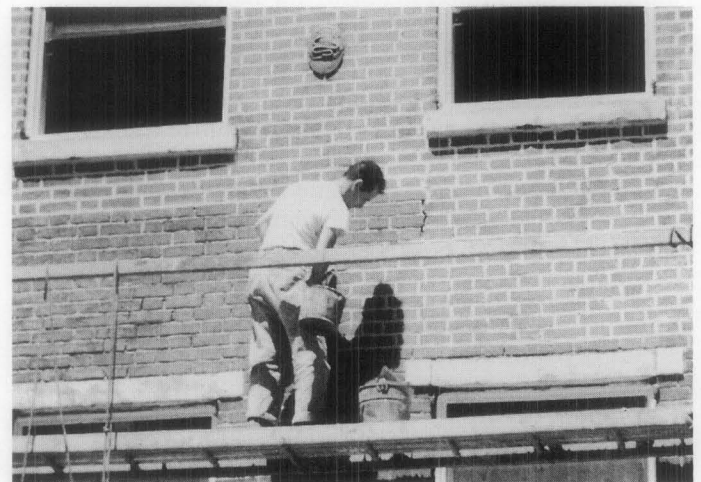
Figure 17. This photograph shows the significant visual change to the character of this historic brick building that has resulted from improper repointing procedures and a noticeably increased thickness of the mortar joints. Photo: Lee H. Nelson, FAIA.

A good repointing job is meant to last, at least 30 years, and preferably 50-100 years. Shortcuts and poor craftsmanship result not only in diminishing the historic character of a building, but also in a job that looks bad, and will require future repointing sooner than if the work had been done correctly (Fig. 17). The mortar joint in a historic masonry building has often been called a wall's "first line of defense." Good repointing practices guarantee the long life of the mortar joint, the wall, and the historic structure. Although careful maintenance will help preserve the freshly repointed mortar joints, it is important to remember that mortar joints are intended to be sacrificial and will probably require repointing some time in the future. Nevertheless, if the historic mortar joints proved durable for many years, then careful repointing should have an equally long life, ultimately contributing to the preservation of the entire building.
